# Respiratory Complaints Clouded by Smoke Then Traced to Vacant Space

P-TRAK™ Ultrafine Particle Counter Case Study #9

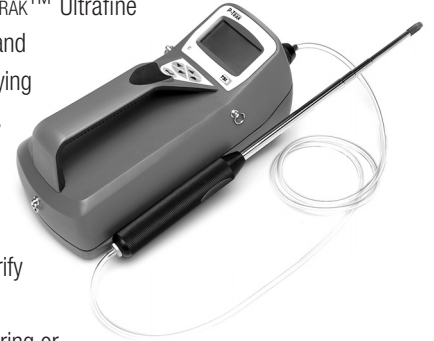
The P-TRAK™ Ultrafine Particle Counter uses fundamental measurement technology proven around the world in research and industrial applications since 1978. Its data logging feature allows the user to download field measurements for evaluation in TSI's TRAKPRO™ Data Analysis Software or in common word processing and spreadsheet programs, simplifying record keeping and reports.
